NSWCCD-TR-61—97/10

Survivability, Structures, and Materials Directorate
Technical Report

SEM Stereo-Section Fractography Observations

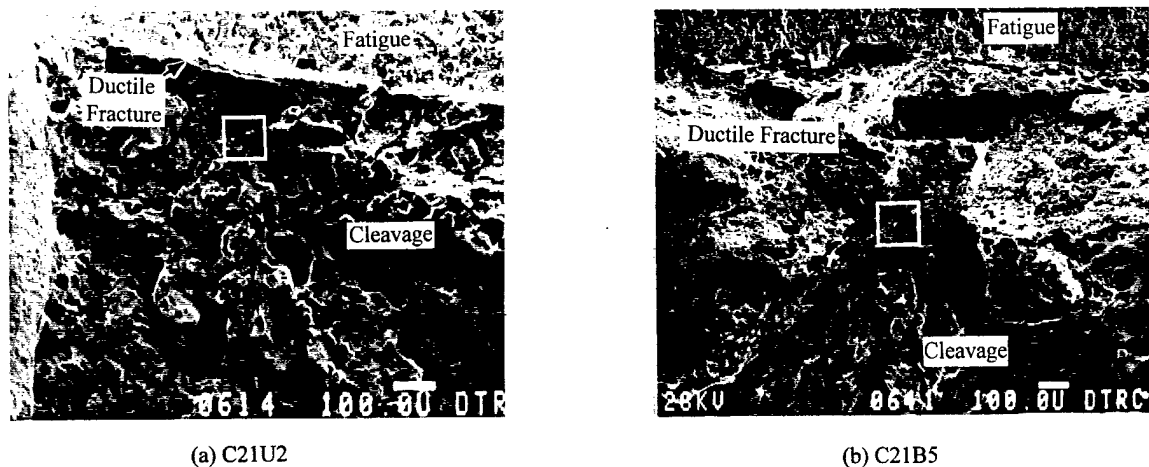
A group of nine $\frac{1}{2}$ T SENB specimens ($B = 25.4$ mm) of A533B steel were tested at -6.7°C and the J-integral values at cleavage (J_c) exhibited wide scatter.⁶ The lowest J_c was 61 m-kN/m^2 (348 in-lbs/in^2) for specimen C21U2 while the highest J_c was 306 m-kN/m^2 (1750 in-lbs/in^2) for specimen C21B5. Low magnification SEM fractographs of the two specimens (Figures 2a-2b) illustrate a significant difference in ductile fracture width between the two specimens which reflects these J_c differences. The inlayed box in each figure identifies the main cleavage initiation region (MCIR). A transverse section (as in Figure 1) was created a few microns away from the cleavage initiation site (CIS) in each specimen. The section was then etched and imaged optically (Figures 3a- 3b) to reveal the adjacent microstructure. The fatigue precrack tip, ductile zone width, and cleavage initiation site are indicated for each specimen in these figures. Their precise locations have been maintained here by tilting the specimen to reveal both the fracture surface and microstructure, identifying distinguishing features on each surface, and then slowly tilting the specimen until the transverse section is normal to the imaging beam. It is then clearly evident that the narrower ductile fracture zone and subsequent rapid onset of cleavage observed in specimen C21U2 is associated with the relatively brittle, dark carbide band. Conversely, the wider ductile fracture zone and higher toughness of specimen C21B5 is

associated with a relatively ductile, lower carbon region. The underlying microstructure explains the substantial spread of J_c in these specimens, but it even more clearly demonstrates Irwin's conjecture that cleavage initiation is a local event which is sensitive to microstructural variation within the material.*

Figure 2: SEM fractographs showing a substantial difference in ductile fracture extension between specimens (a) C21U2 and (b) C21B5.

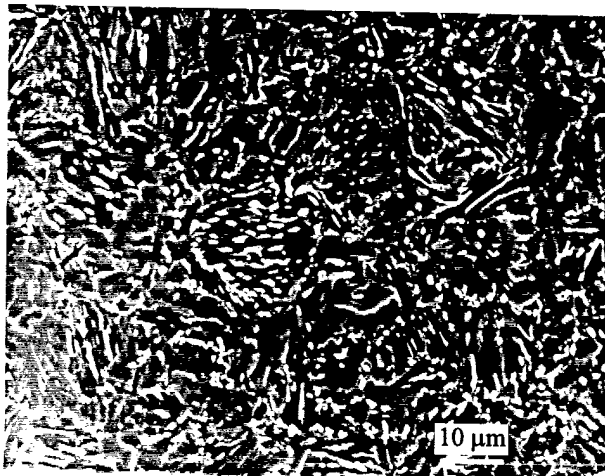
Figure 4c: An SEM micrograph of tempered martensitic or/and tempered bainitic structure of the light band in 4a.

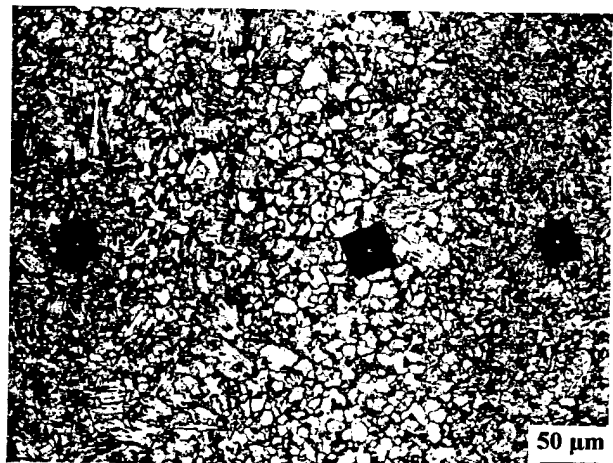
Figure 4d: An optical micrograph showing a significant difference in Vickers indentation size between the two microstructures.

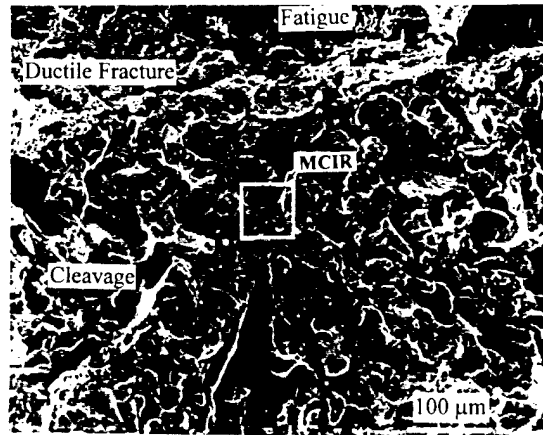
Figure 5a: A conventional SEM fractograph of specimen BB10 showing the location of the MCIR.

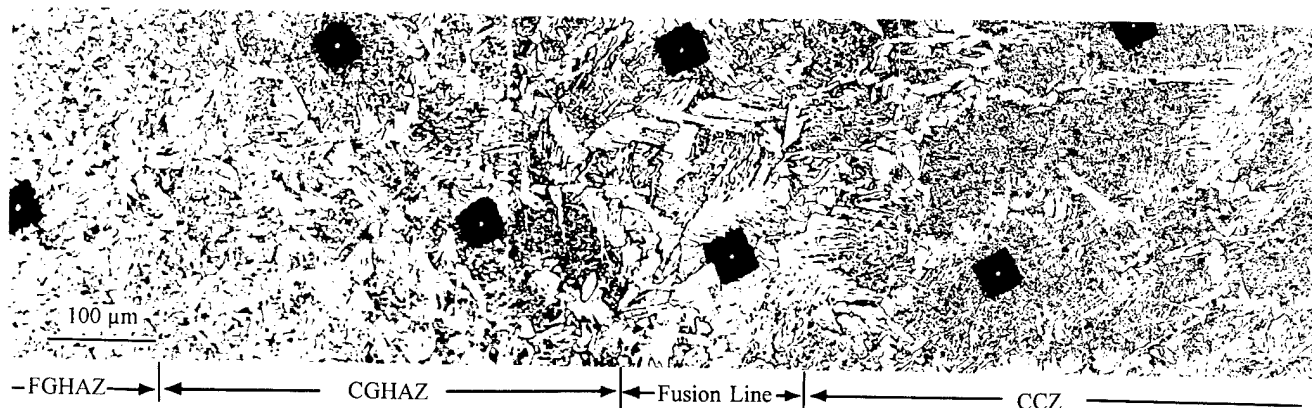
boundaries, Widmanstatten side plates, acicular ferrite, and carbide particle clusters. The features of these bands compared to the remainder of the weld bead microstructure suggest that this narrow region surrounding the fusion zone is the most brittle. Therefore, the CGHAZ and edge of the CCZ should serve as the preferential cleavage initiation region for this group of weldments.

Figure 8b: The microstructure surrounding the fusion line of one weld bead; line A-A in 8a.

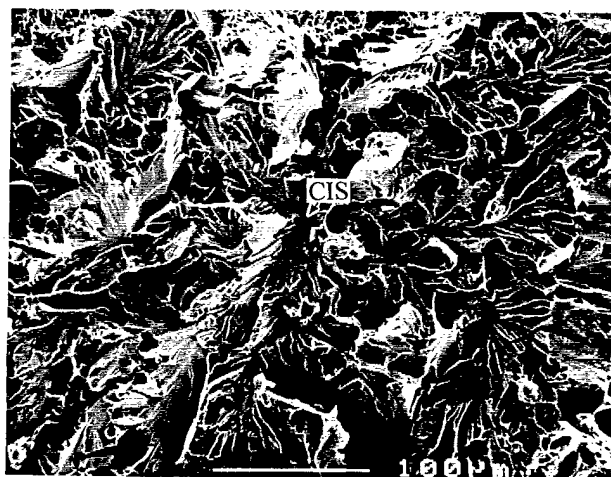
The SSF results indicated that the MCIS in four of the five sectioned GXK specimens was located at the edge of the CCZ, adjacent to the fusion line. Specimen GXK 62 is typical of these specimens. The unsectioned fracture surface of this specimen (Figure 9a) clearly indicates the dominant CIS. The focal point of the site (within the white box in Figure 9a) is enlarged in Figure 9b and the cleavage initiation site has been identified by the black arrow. A transverse section was then prepared approximately 10 μm from the cleavage initiation site. Figure 9c shows the fracture surface and transverse section simultaneously after tilting the specimen 45° about the sectioning axis. In the figure, the small triangular cleavage facet near the cleavage initiation site (indicated by black arrow) was used to identify the location of the MCIS as the section was rotated to view solely the transverse microstructure surrounding the CIS and fatigue precrack (Figure 10). It is evident in Figures 9c and 10 that cleavage initiation was associated with long ferrite plates at the edge of the CCZ, adjacent to the fusion line. Further, it is evident that (1) the tip of the fatigue pre-crack was located in the middle of the CCZ; (2) ductile crack growth proceeded through the CCZ for approximately 1 mm without triggering cleavage cracking; and (3) cleavage was triggered only when the edge of the CC microstructure was sampled by the crack tip. As mentioned earlier, four of the five GXK specimens examined also exhibited cleavage initiation only within the CCZ, near the edge of the fusion line.

Figure 9b: An enlargement of the MCIR in 9a.

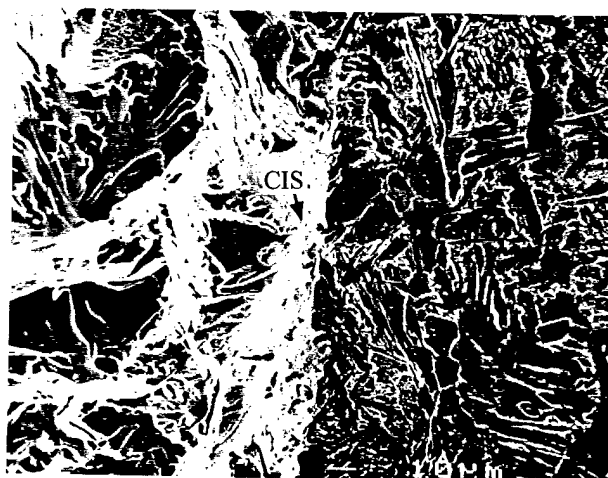
Figure 9c: Fracture surface and microstructure of the CIR region: tilted 45° about the section axis.

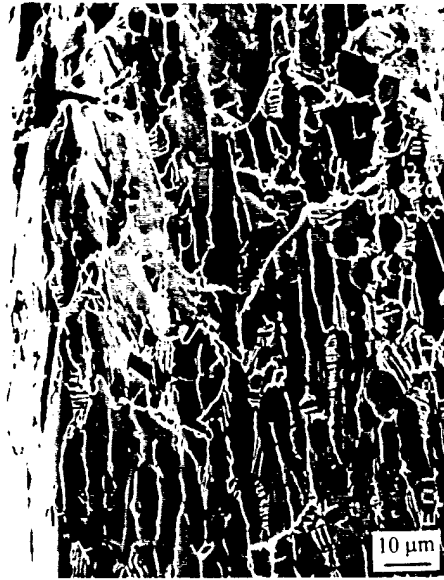
These pictures elucidate the correspondence between the secondary cracking path and the orientation of the elongated α grains. The α grain orientation texture was produced during the solidification process and was not eliminated by subsequent heat treatment. The crystallographic appearance of this cracking implies that a cleavage-type mechanism may govern this phenomenon. This out-of-plane cracking is not desirable because of both its brittle nature and the fact that it implies this microstructural orientation is much weaker than in the normal plane within these regions. The texture can be eliminated through proper solution heat treatments to form either randomly oriented, equiaxed α grains mixed with $(\alpha + \beta)$ constituents, or a fully transformed structure. A more homogeneous, isotropic, and stronger fracture performance should then be achievable.

Figure 14d: Enlargement of the boxed area in Figure 14c: a good correlation between etched microstructure and secondary cracking fracture planes is apparent.
